Rio Mora
Stream Inventory Report
Santa Fe National Forest
Surveyed: June 2007 to August 2007

Report By
Andrew Erdmann
Hydrologic Technician

Santa Fe National Forest
February 2008

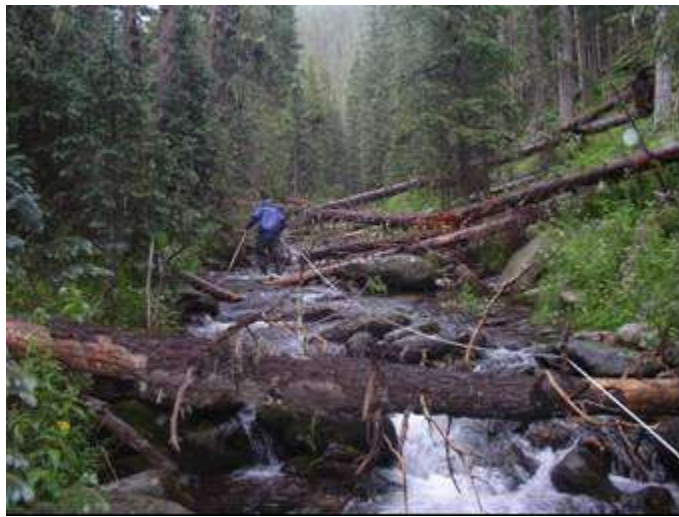
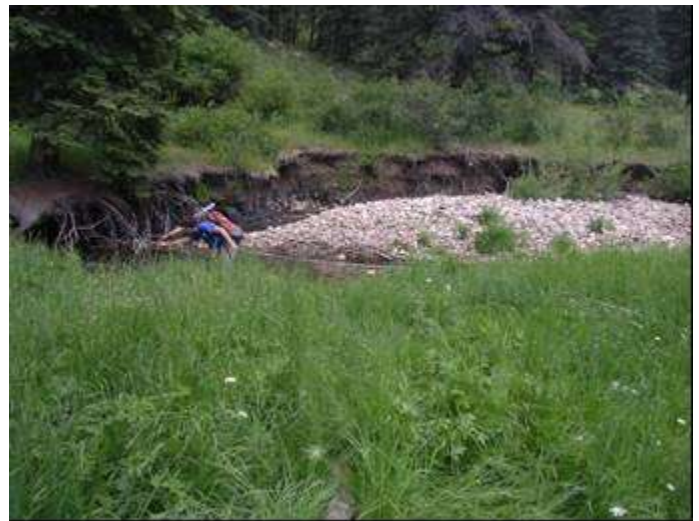
Generally, the banks are in excellent condition, with less than 5% instability. For the most part, this instability was concentrated in the first reach, near the campground, in the meadows below the Valdez, and in the intensively grazed area in the uppermost reach. Each of these three reaches has bank instability in excess of 10% of the total length, which qualifies them as not properly functioning. More intensive management of grazing allotments and heavily used recreation areas might help to alleviate this problem.

Photo 5 - LWD in reach 8, bank instability in Reach 4.

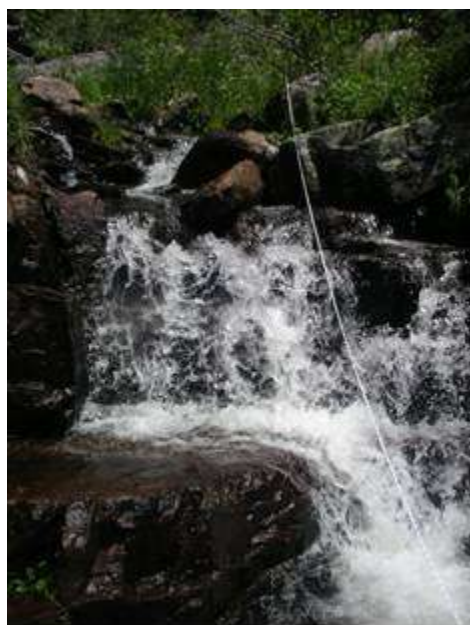
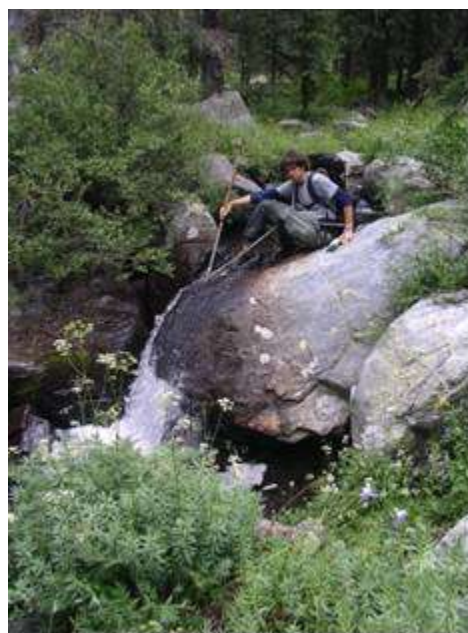
A previous survey conducted in the summer of 2005 by NMDG&F revealed that the uppermost mile of the river – which had previously been considered RGCT habitat – did not encounter any fish while electro-fishing (Howes, 2007). This may be due to the river either going dry or freezing solid from its headwaters to a series of natural fish barriers located (see photo 10) from 1.5 – 2 miles downstream.

Photo 8 - Two barriers located in reach nine which may be the final barrier to all fish in the stream.

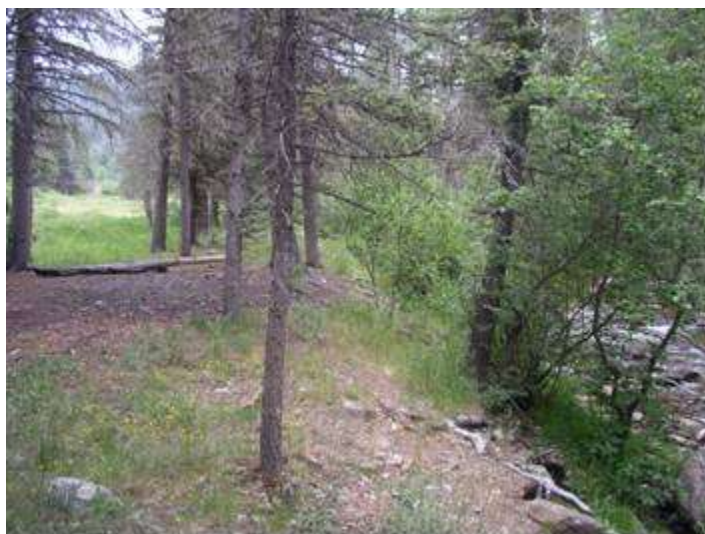
The Mora Flats is the most heavily used recreational area along the Mora in the Pecos Wilderness. This site is most easily accessed from the Iron Gate Trailhead with a short 3-mile hike. Access is also possible from the more remote Sparks trailhead, which is above Rociada, NM on the eastern side of the mountains. The Mora Flats has a popular campground located on the western side of the Mora north of the point where trails 240 and 226 cross the river. The southern half of the flats appears to be used primarily by cattle,

Photo 11 - Streamside campsite in the Mora flats.

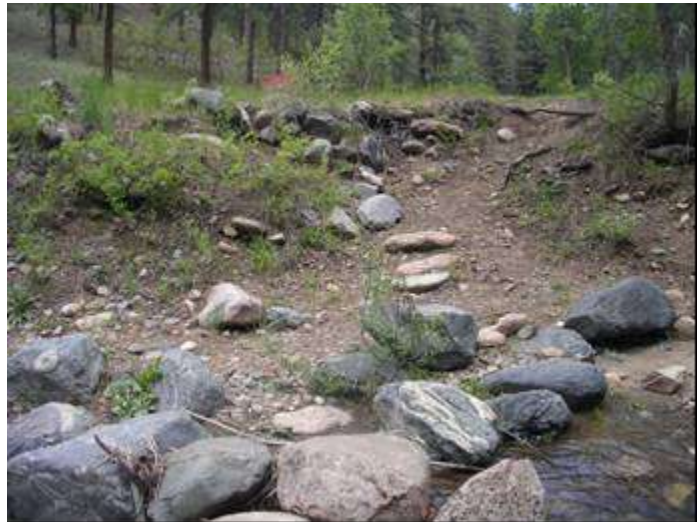
Photo 15 - Erosion at a river access point near Mora campground.

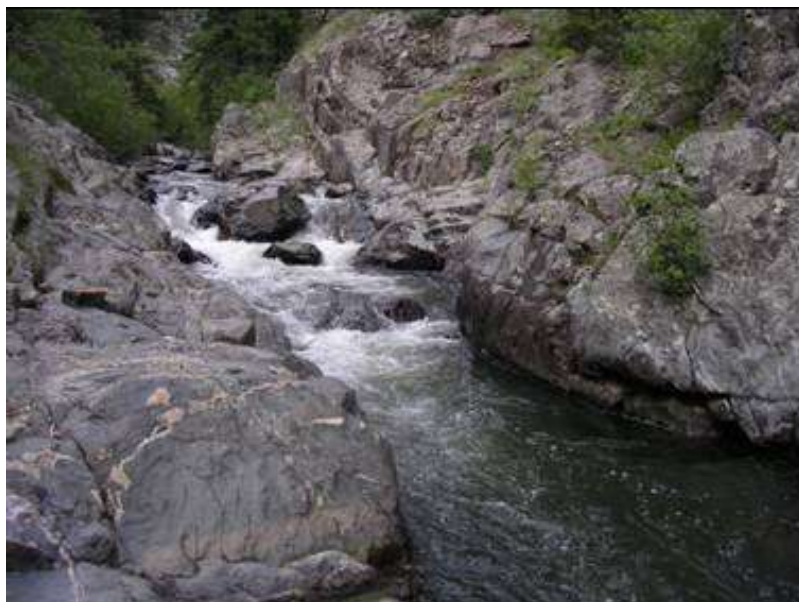
Photo 16 - Bedrock chutes creating a possible barrier location.

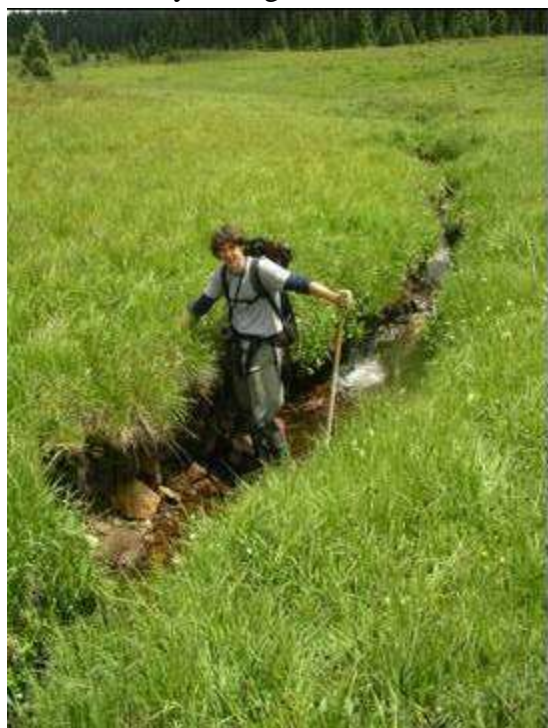
Photo 36 - Incised channel at low flows.
